Silicon Precipitate Nodule-Induced Failures of MOSFETs

M. Johnson and D. Pote
Motorola, Inc.
Northbrook, IL

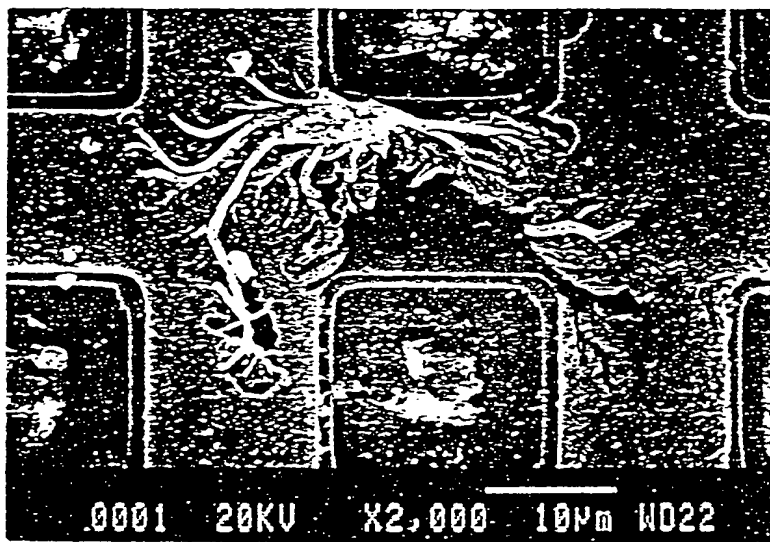
Figure 1: Unique pattern of fused polysilicon observed after removal of metallization and insulating oxide. (2000X)

Subsequent optical inspection identified an apparent electrical damage site under the wirebond. This damage was characterized by a central fused-site surrounded by multiple filaments (Figure 1). These filaments were dubbed "tentacles" or "roadkill" damage because of their appearance. SEM inspection of the same locations revealed surprisingly little

It is now believed that the filaments are the result of amplification of the damage at the original failure sites by the application of excess power during liquid crystal testing. A slightly higher level of power was necessary to counteract the obstructing heatsink effect of the relatively large wirebond. The heat generated at the damage site would initiate crystallization of the amorphous polysilicon depend-

ing on the amount of power dissipated. If the applied power during LC testing was maintained at 25 mW or less, little or no filament growth would occur. Deliberate "decoration" of the damage site by generating filamentation was a useful albeit destructive technique to simply confirm the presence of this failure mechanism since it requires only a readily available medium power optical microscope to locate the damage site.

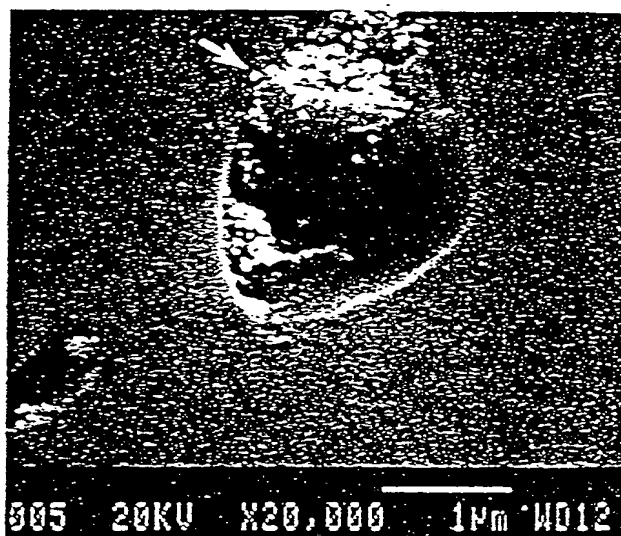
Figure 2: Small electrical damage site within chip.
(25000X)

Cross-sections of failures revealed that the filaments were confined to the polysilicon layer, except at the central nucleus. At the nucleus, melted silicon and aluminum were observed extending vertically through the dielectric layer. On several devices where the filamentation was minimal, there was limited evidence of melting at the nucleus site and a small section or chip of the dielectric was missing (figure 2).

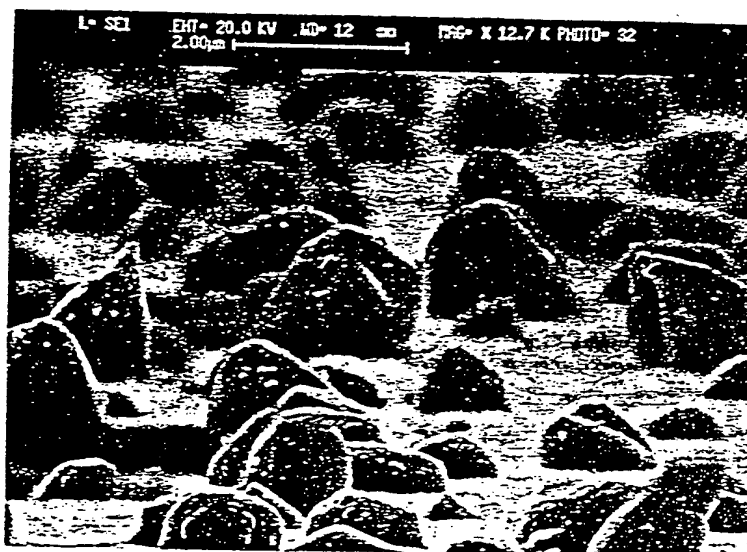
shape. Although they appear roughly circular under high power microscopy (400X), they are actually polyhedral and exhibit a wide range of aspect ratios (Figure 3). Typical height/width ratios range from 0.3 to 1.8.

Figure 3: Silicon precipitates (nodules) viewed from side exhibit variety of shapes and sizes. (12700X)

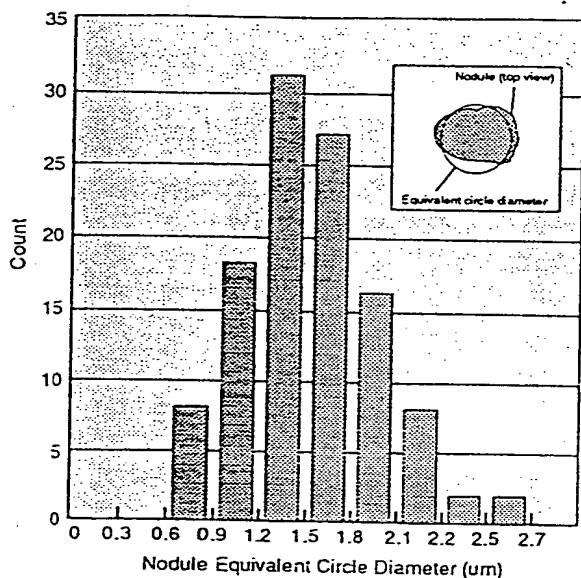
There were typically 50×10^3 to 100×10^3 nodules per square millimeter in the subject devices. In general, the nodule density -- the number of nodules per unit surface area -- was inversely proportionate to the average size of the nodules. That is, when the nodules were large, there tended to be few of them. Conversely, when the nodule count was high, they tended to be small. Figure 4 shows a typical histogram of nodule sizes produced by an image analysis

Figure 4: Example distribution of nodule sizes

system capable of performing feature counting. Unfortunately, easily measured characteristics of the nodules, such as density (count/area), could not be easily correlated to failure rate. It is hypothesized that the probability of failure is governed by extreme value statistics (weakest link theory), and detailed info regarding the shape and size of the nodules can be difficult to obtain on a large number of samples.

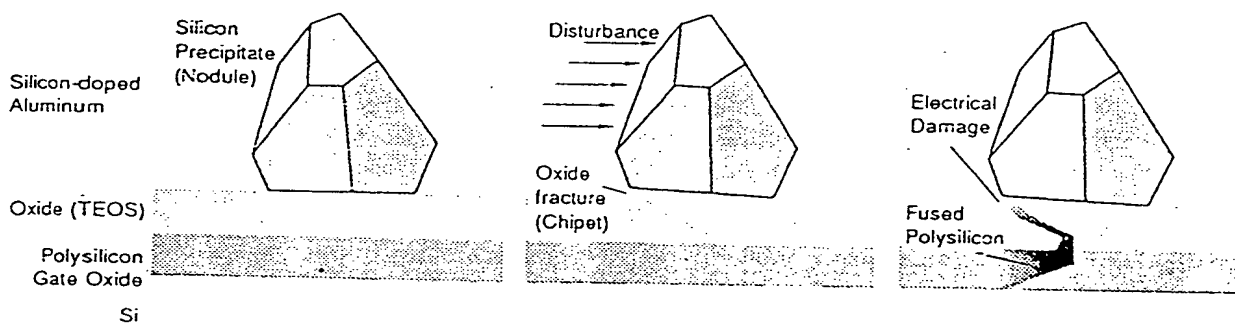
The adhered nodules could be removed quite easily; gentle brushing of a few fibers from a cotton swab was sufficient to disturb them. When these well-adhered nodules are displaced, they often take with them a portion of underlying oxide, forming a distinctive, football-shaped chip-out, or *chipet* (Figure 5). The depth of the resulting chipet was roughly equal to half the length of the chipet's minor axis, itself related to the area of contact between nodule and oxide.

In the MOSFET devices the lateral displacement of the nodules occurs during the wirebonding process. The cavity formed by the chipet is immediately filled with aluminum. These chipets, during

Figure 5: Movement of nodule results in fracture of underlying oxide.

electrical stress, appear to act as weak points in the insulating oxide. If the chipet is sufficiently deep to fully compromise the thickness of the dielectric oxide, a linear resistive short between the source metallization and gate polysilicon results. However, if the root only partially compromises the dielectric, a leaky diode-like characteristic results.
